Watershed Survey

O. O. Denny Creek

Denny Creek Neighborhood Alliance

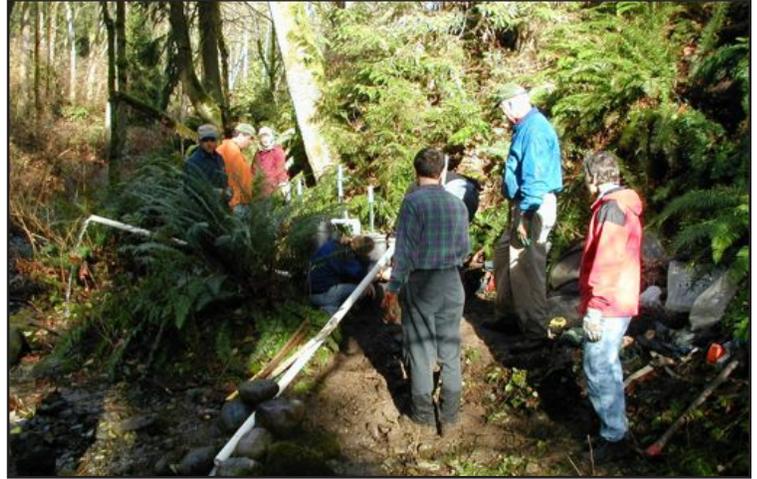
A concrete bridge had been built over the stream sometime in the 1930’s, and erosion had gradually etched an 8-foot fall, effectively blocking fish passage. In 2000 - 2001 DCNA designed, and funded King County to construct, a fish ladder in Big Finn Hill Park below the concrete bridge. Funding for the project was secured by several government grants. The fish ladder project was completed in 2002.

Of the many projects spearheaded by DCNA⁵, one of the most capital-intensive was the construction, in collaboration with King County, of a fish ladder designed to enable fish to access the upper reaches of the stream.

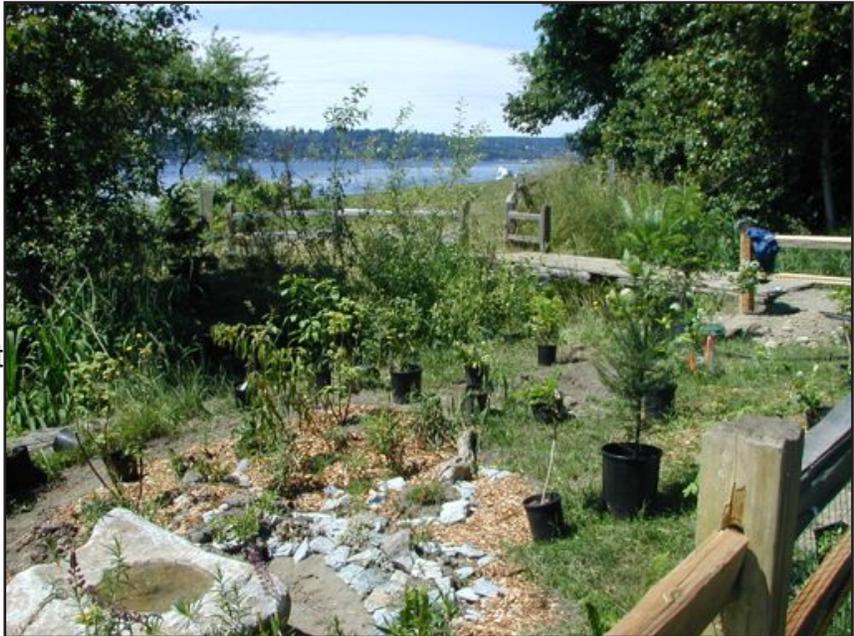
Native vegetation and butterfly garden at mouth of stream

Commencing at the stream's mouth, the riparian area consists of bulkhead lake frontage and mowed park lawns, with an over story of black cottonwood and alder. Stream banks are scattered with sword ferns and become greatly incised as you proceed upstream. Near the mouth of the stream, banks are undercut and erosion has resulted in the loss of mature canopy. Further upstream of the mouth, toward Holmes Point Drive, mature trees and vegetation provide adequate streamside cover. A stream restoration project during 1995 planted native species (including willow, Nootka rose, elderberry, snowberry, and cedar) along the stream banks below Holmes Point Drive. Currently this lower reach lacks adequate streamside cover and woody debris. Near the area where the stream enters the lake, some fencing, native vegetation, and a butterfly garden were added in 2006.

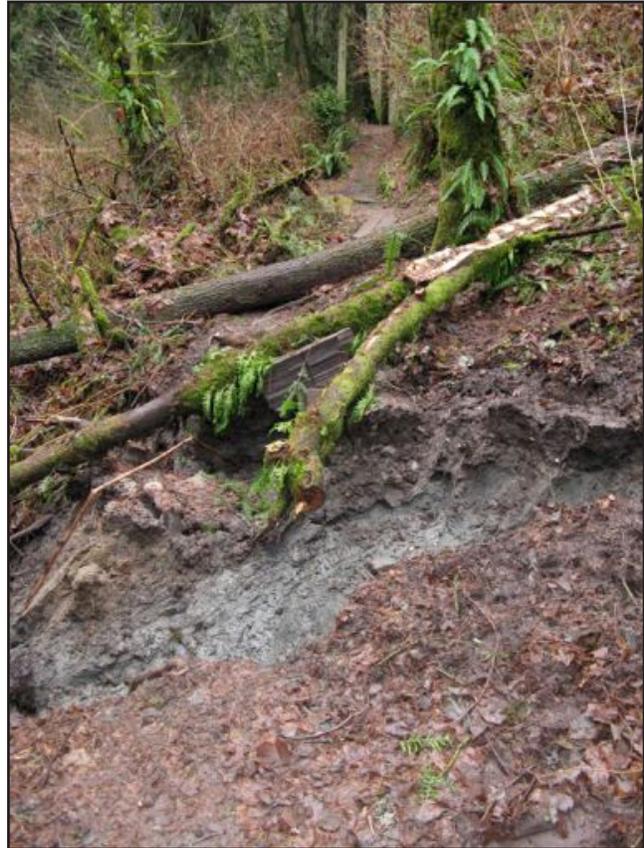
King County's LIDAR Digital Ground Model (DGM) shows many potential landslides and existing erosion sites adjacent to Juanita Drive NE in the O. O. Denny Creek watershed. Most of these sites are continuing to erode, exacerbated by the channeling of storm flows through

Bank erosion cuts through trail

culvert outflows or increased flows due to the loss of forest cover to the impervious surfaces of new developments. Most of the steep hillsides within the watershed meet the definition of “sensitive areas” by County Ordinance 15051¹⁰ and are identified in the King County Landslide Hazard Areas Map¹¹. Land use and land use planning actions, however, have seemed to forget that increasing impervious surface and the removal of the vegetation on the uplands increase storm runoff, which is then channeled into existing erosion sites adjacent to Juanita Drive NE within the O. O. Denny Creek Watershed.

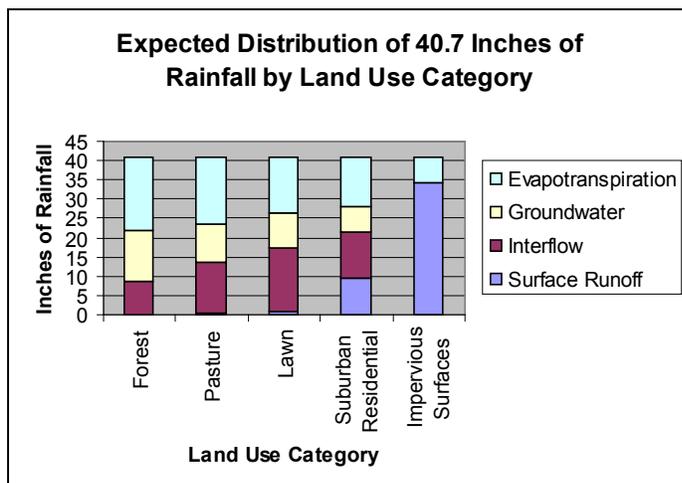
Figure 2 - Expected Distribution of 40.7 Inches of Rainfall by Land Use Category

Using the estimate of 40.7 inches for Seattle’s average annual rainfall, the graph at left shows the typical distribution of this annual rainfall for each land use category, in the general case.

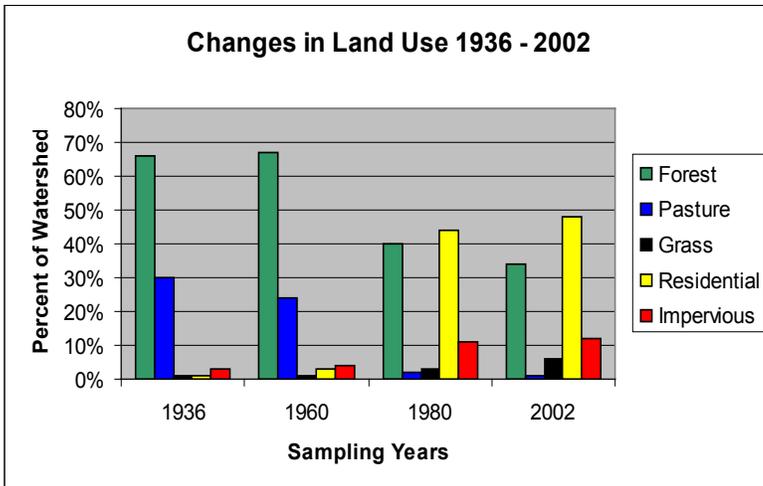
Figure 3 - Changes in land use 1936 - 2002

The percentage of the watershed fitting each of the 5 land use categories in each of these 4 years is shown in the graph at left. This is an attempt to quantify the shifts in land use that are known to have occurred.

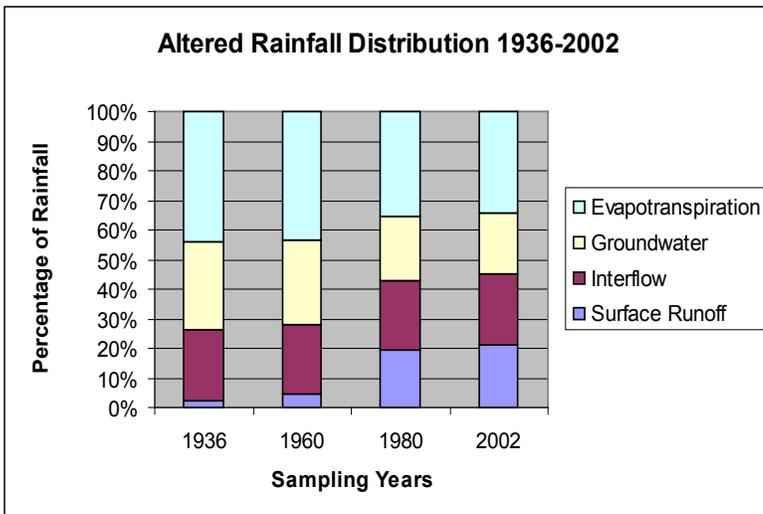
Figure 4 - Altered Rainfall Distribution 1936-2002

The land use data were then combined for each year to illustrate how the shifts in land use have altered the runoff of our annual rainfall. This is shown in the graph at left.

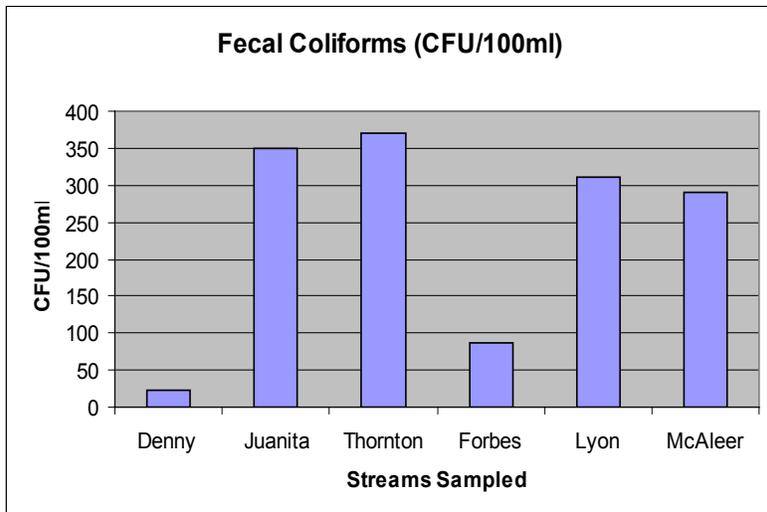
Figure 5 – Fecal Coliforms (CFU/100ml) of selected Lake Washington tributaries

CFU = Colony-Forming Unit

Applicable WA standard for Primary Contact – Recreation “Fecal coliform ... must not exceed ... 100CFU/100ml”

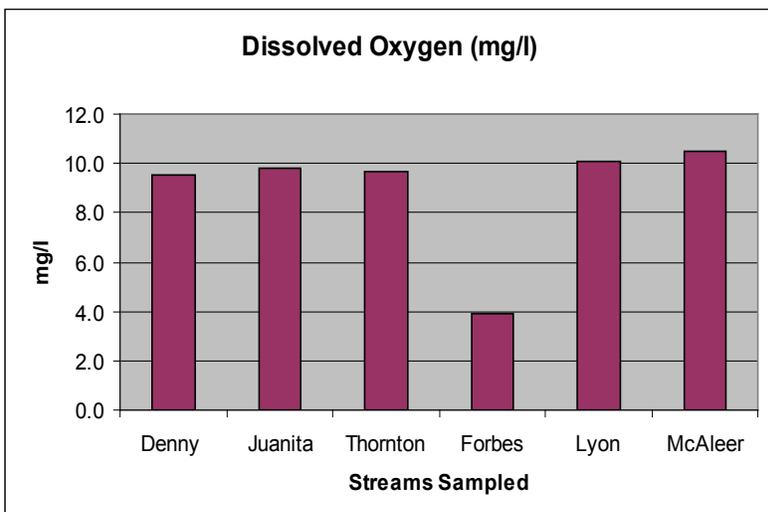
Figure 6 - Dissolved oxygen values in selected Lake Washington tributaries

Applicable WA standard for dissolved oxygen >8mg/l

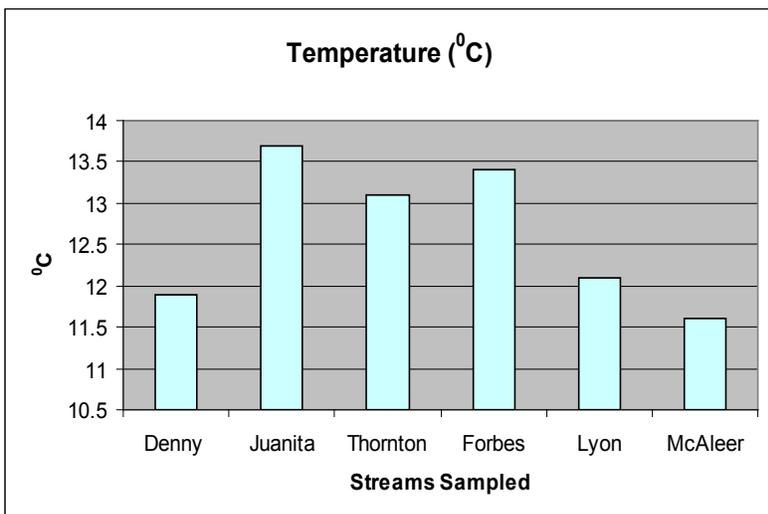
Applicable WA standard for water temperature <17.5°C

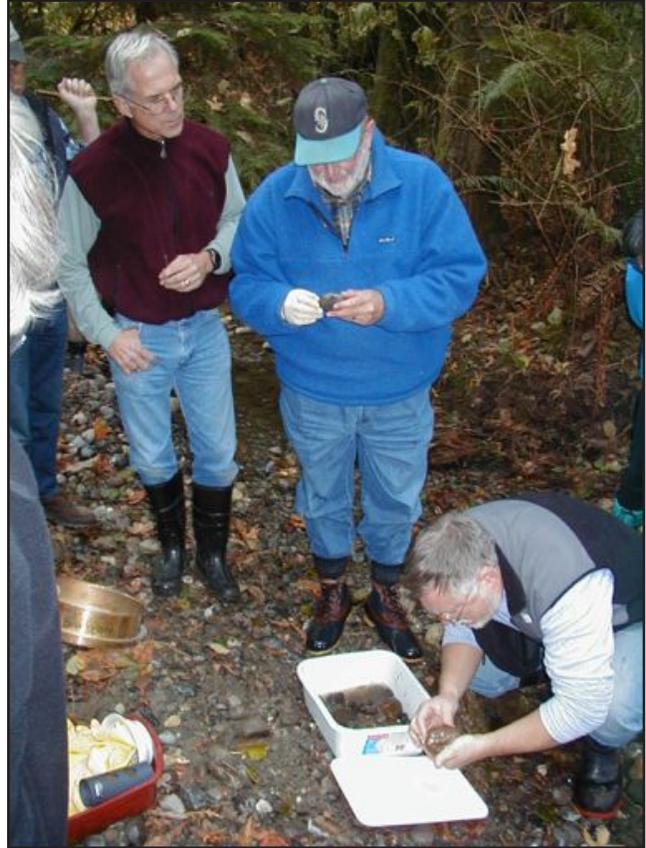
Watershed team conducts IBI

To determine the health of O.O. Denny Creek and its suitability as a spawning site for salmonids, sampling of benthic macroinvertebrates (BMIs)¹⁶ was carried out (Appendix F). An index of biological integrity (IBI) was obtained on several occasions and compared with reference data from streams in varying settings and with varying degrees of biological degradation.

The results of these samplings showed the biological condition to be in the range of slightly-to-moderately degraded; probably within an index value that could be expected to sustain a salmonid population and reproduction if other conditions were suitable. We believe that the protection that the stream receives from its substantial riparian corridor within the adjacent parklands ensures a biological condition and natural processes which are superior to neighboring streams that are absent a substantial natural buffer.

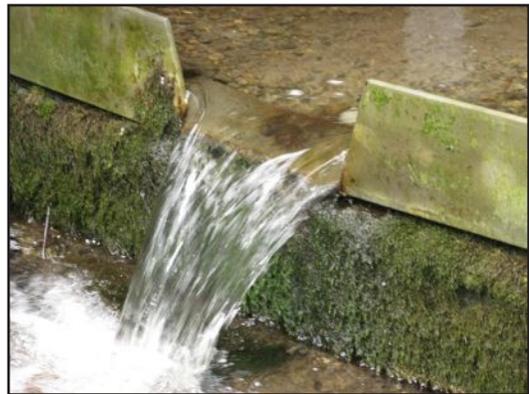
Trapezoidal-notched weir

Fish Ladder Weir – During the construction of the Denny Creek Fish Ladder in 2002, DCNA installed a trapezoidal-notched weir downstream of the concrete culvert as the stream enters the fish ladder. The weir is accurate for low flows but becomes less accurate when the flows exceed three times the height of the six-inch metal weir. Flow observations were made during the study and a rating curve was developed to determine flows. This curve is an approximation of the volume of water going over the weir. Water depths are measured about 1 ½ feet upstream of the weir. Use the first graph for depths under ½ foot and the second for depths over ½ foot (curve is not valid for depths exceeding 1 ½ feet).

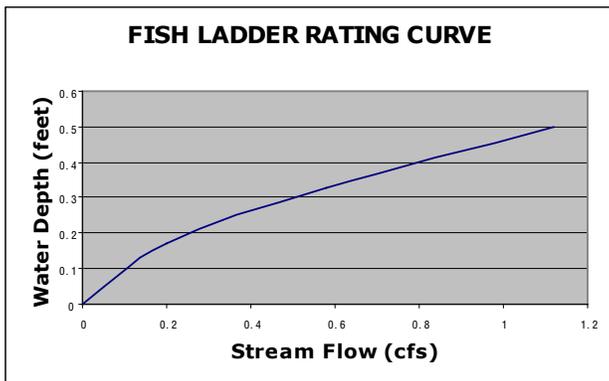
Figure 8 - Curve for water depths under 6 inches

By observing the depth of the water on the staff gage just upstream of the weir and finding this value on the vertical axis of the graph, stream flow is determined by the flow value directly below the intersection of the water depth with the rating curve of the graph. Full-page working graphs are provided in Appendix H.

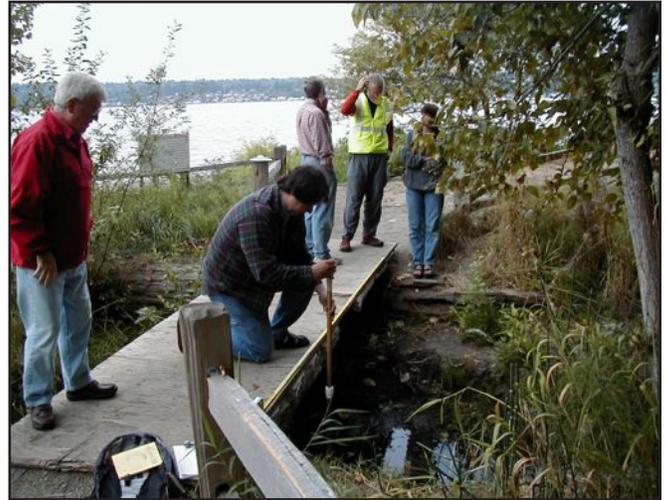
Flow Probe – During the course of the study, two Global Water Flow Probes were purchased to study instantaneous and mobile stream flows. During rain storms these were employed to determine flows at several locations in the watershed. The meters are hand-held rods with a flow meter attached at one end. The meter reads instantaneous velocities of the stream and also accumulates the data as the probe is moved across the stream or culvert to obtain an average velocity. Flows are then computed by measuring the cross section area of the water in the pipe or in the stream and multiplying the area by the average velocity. Results of this effort can be seen in Appendix G.

Measuring stream flows

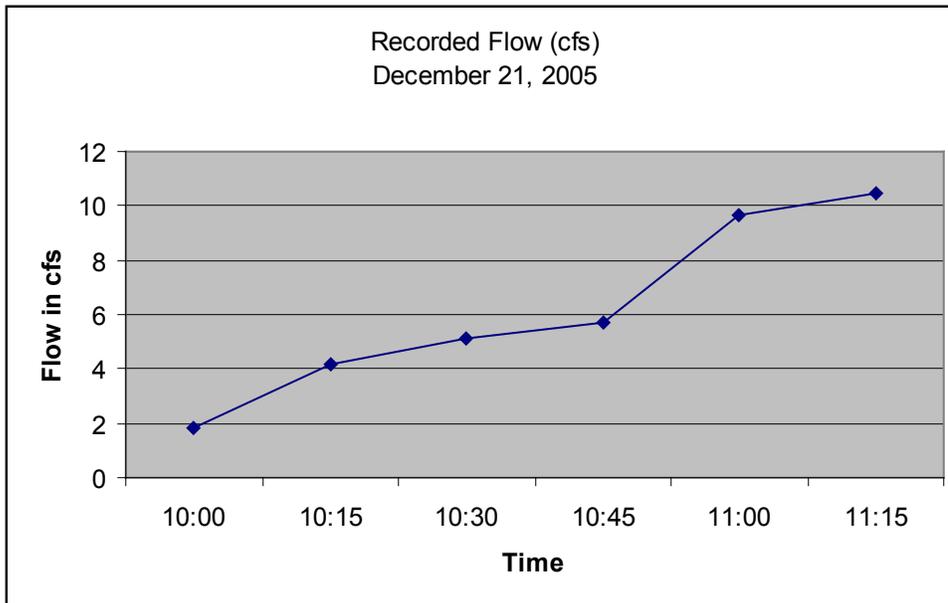
Figure 10 - Stream flows in 15-minute intervals for December 21, 2005

to 35 cfs to 17.05 cfs. To illustrate just how fast the stream can rise, the following graph shows recorded flows in fifteen minute intervals for December 21, 2005.

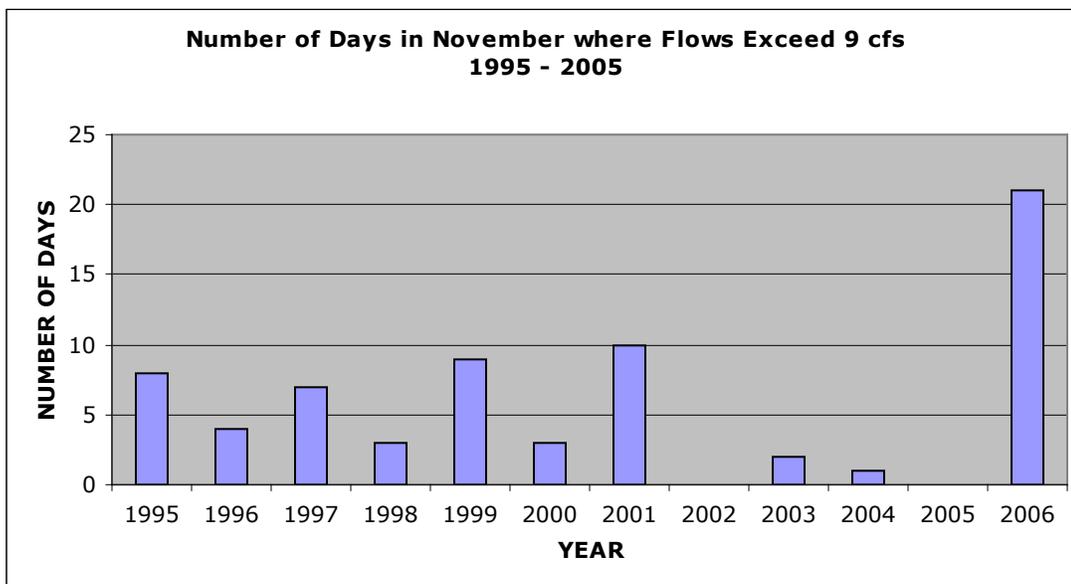
Figure 11 - Number of Days in November where Flow Exceeds 9 cfs 1995 – 2006

If we assume 5-10 days as a minimum range, the graph below showing the last twelve years for which we have flow data (records for 2005 are not available, as King County removed the

Looking specifically at the expected return years for eggs incubated in the stream (2003-2006) Denny Creek had adequate flow on a sufficient number of days only in 2006 (**as noted earlier, data are missing for 2005**). Recorded November flows for years 2003, 2004, and 2006 are depicted in the series of three graphs that follows.

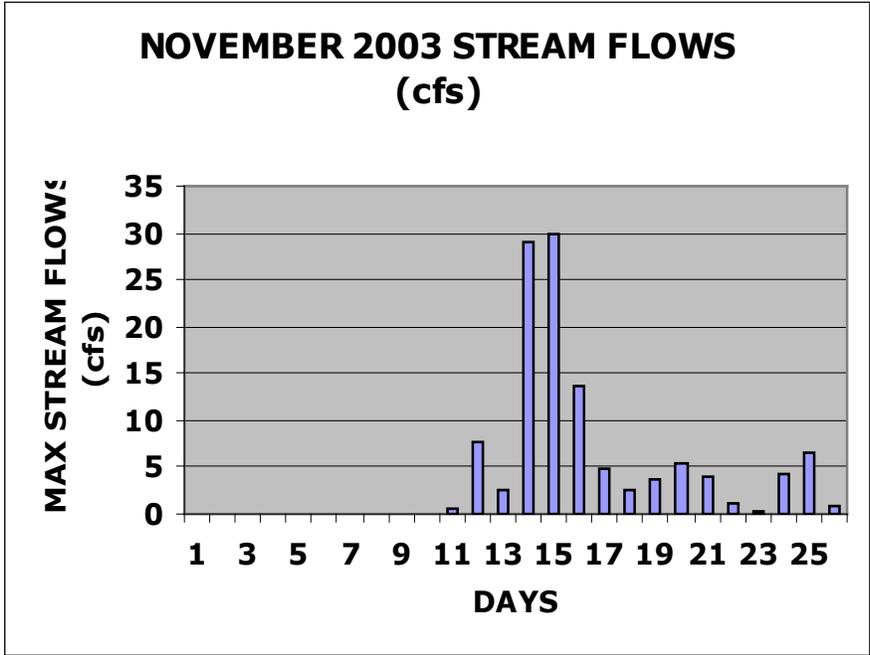
Figure 12 - November 2003 stream flows (November 2003 rainfall of 6.77")

As shown in the graph for November 2003, there were only three days during that month that stream flows exceeded 9 cfs, and for only short periods of time.

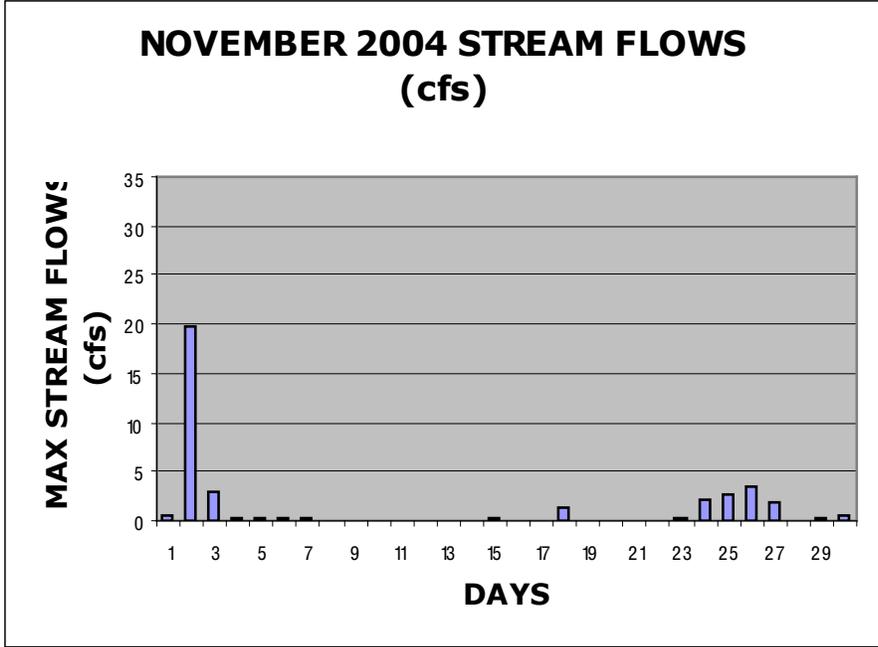
Figure 13 - November 2004 stream flows (November 2004 rainfall of 3.16")

Year 2004 had only one day that met the desired flow.

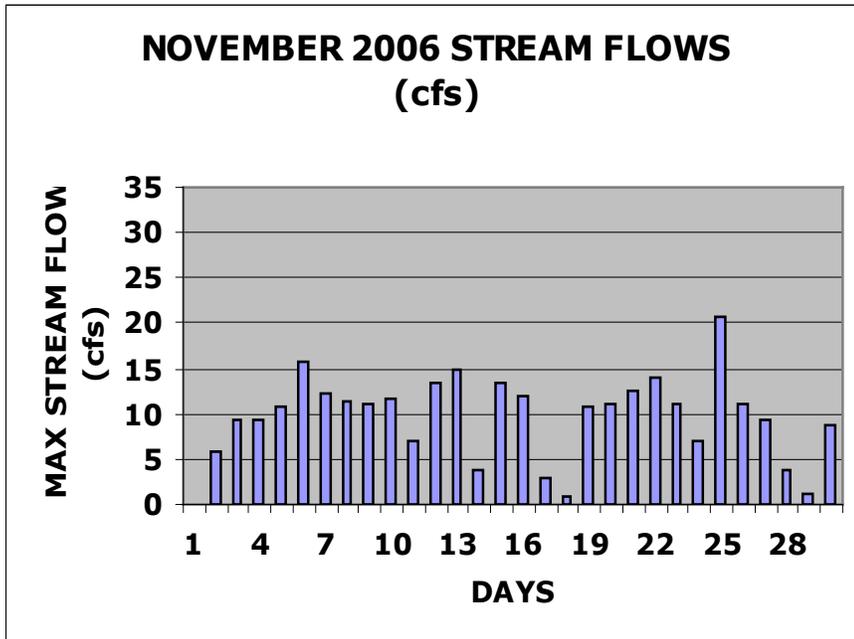
Figure 14 - November 2006 stream flows (November 2006 rainfall of 15.63")

In contrast, November 2006 had 21 days where the flows met 9 cfs and three adult Coho salmon were observed, two upstream of the fish ladder.

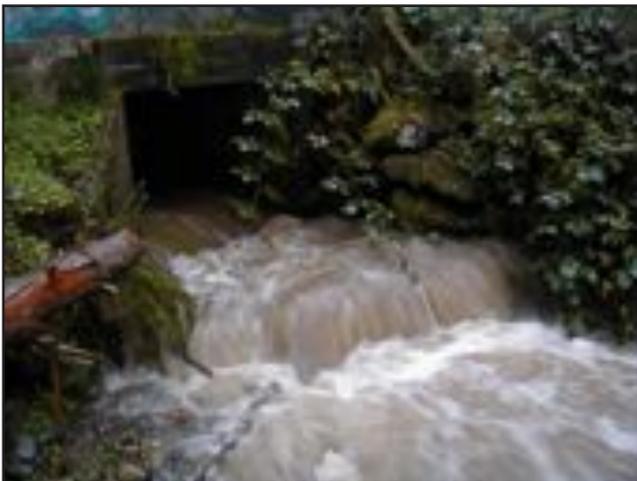
Stream flow at peak on January 30, 2006

On January 30, 2006 the stream flow rate at peak time was changing 4 cfs every 15 minutes.

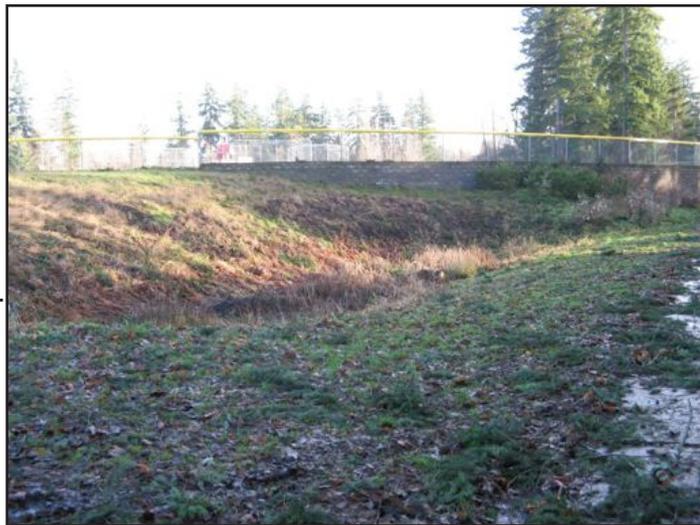
Retention pond in Big Finn Hill Park

Retention/Detention Facilities - Many of the retention ponds constructed in the past have been observed to be empty during periods of high runoff. Underground tanks and vaults were not inspected but there are concerns over the maintenance of these

control devices. During the inspection of one retention pond the control valve was found to be shut off for an unknown reason.

The two retention ponds located in Big Finn Hill Park, according to a King County Senior Stormwater Engineer, would not meet current design standards and are inadequate to handle existing storm flows. The northern-most pond is in a deteriorating condition and is very ineffective in all but the smallest storm events. Another detention pond, the one located at 128th and Juanita Drive, was observed by DCNA team members to have no accumulated water during a heavy rain event.
